## RESIDENTIAL REPORT

Lido Presidential

845 Benjamin Franklin Dr,  
Sarasota FL 34236

Phase One Milestone Inspection

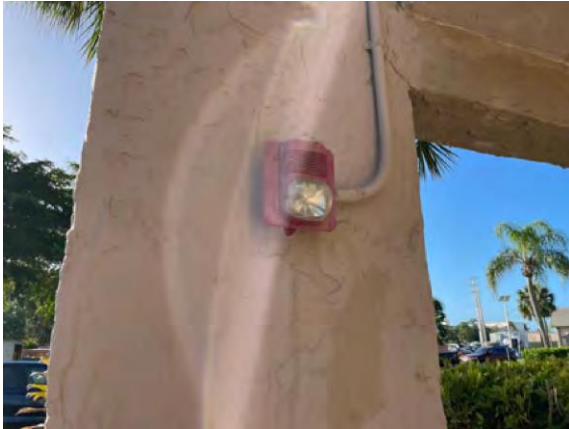
1.o.1

1. Minor cracking in column on second level, above exit light.
2. Minor stucco cracks in walls in between floors and on the right wall behind gutters . General maintenance.
3. Spalling and exposed rebar under first landing in front of unit 109.
4. Minor rust on exterior walls, due to likely to rusted rebars between floors. To be repaired and painted.
5. Minor rot in wood paneling of ceiling of bldg A 4th level .
6. Minor to moderate rust on fire risers/piping including the fire riser between Units 105 and 107.
7. the 4th floor exit light, front/left corner of Building A needs repair. Part of maintenance activities.
8. Minor cracking in Control Joint in the ceiling outside Unit 301.

1. Minor cracking in column on second level front left corner above exit light.

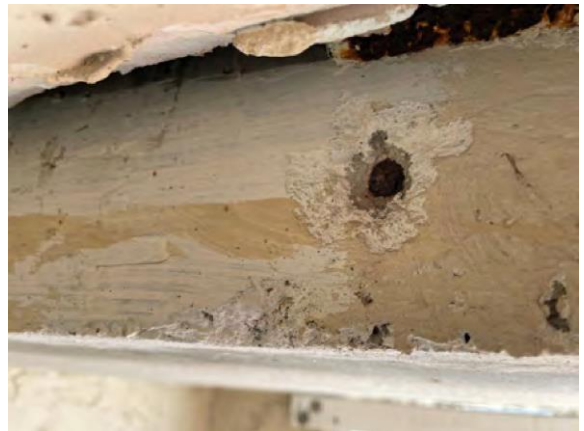
1.o.3

See items in 1. o.3

k. Rebar corrosion-check appropriate line
1. None visible
X 2. Minor-patching will suffice (Item 1.o.3)
3. Significant-but patching will suffice
4. Significant-structural repairs required
l. Samples chipped out for examination in spall areas
X 1. No
2. Yes – describe color, texture, aggregate, general quality
<b>NOTES: N/A</b>
