STRUCTURAL INTEGRITY RESERVE STUDY

Lido Presidential

845 Benjamin Franklin Dr
Sarasota, Florida 34236

November 17, 2023

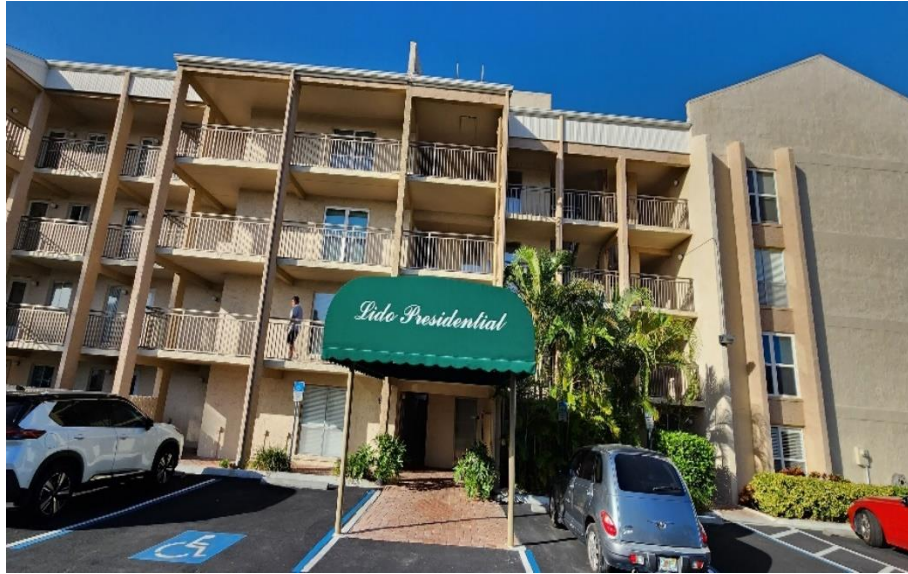
PHOTO 1

GENERAL VIEW OF PROPERTY

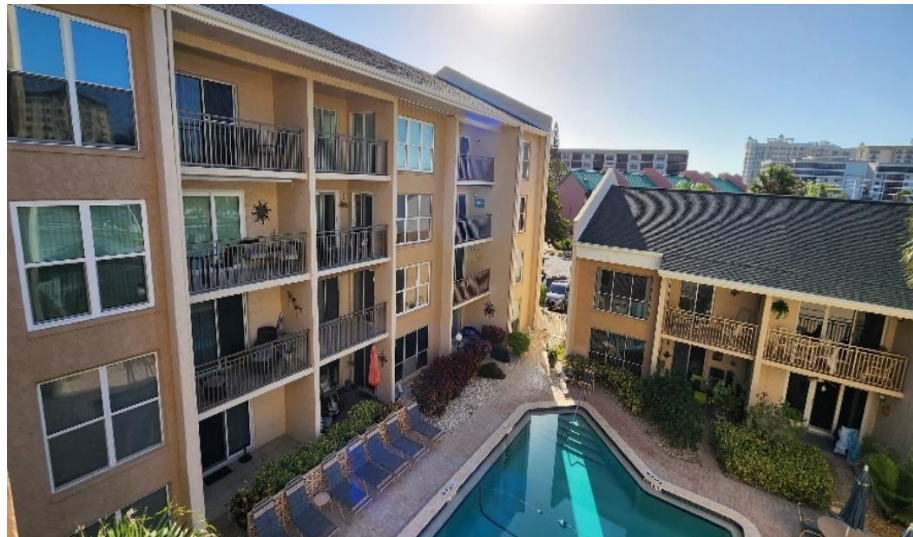
PHOTO 2

GENERAL VIEW OF PROPERTY

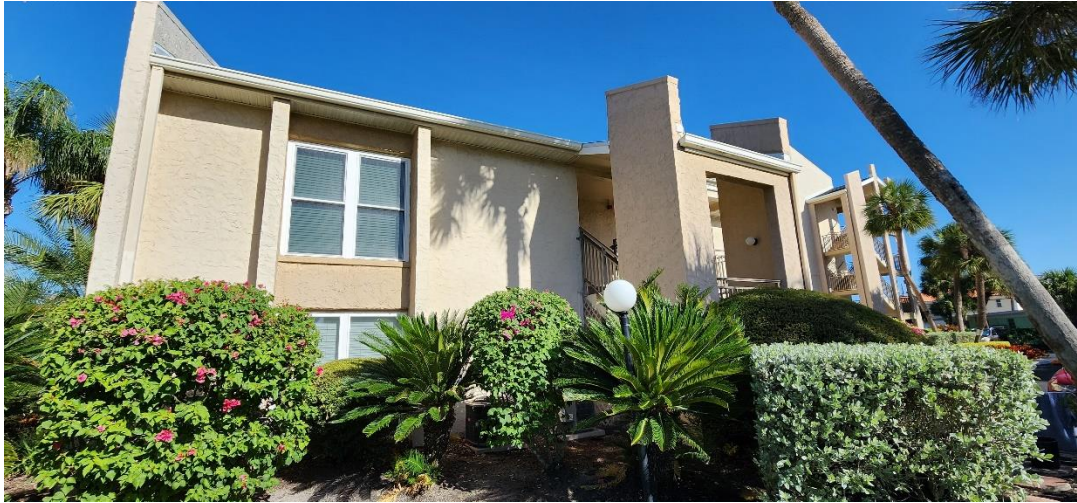
PHOTO 3

GENERAL VIEW OF LANDSCAPING

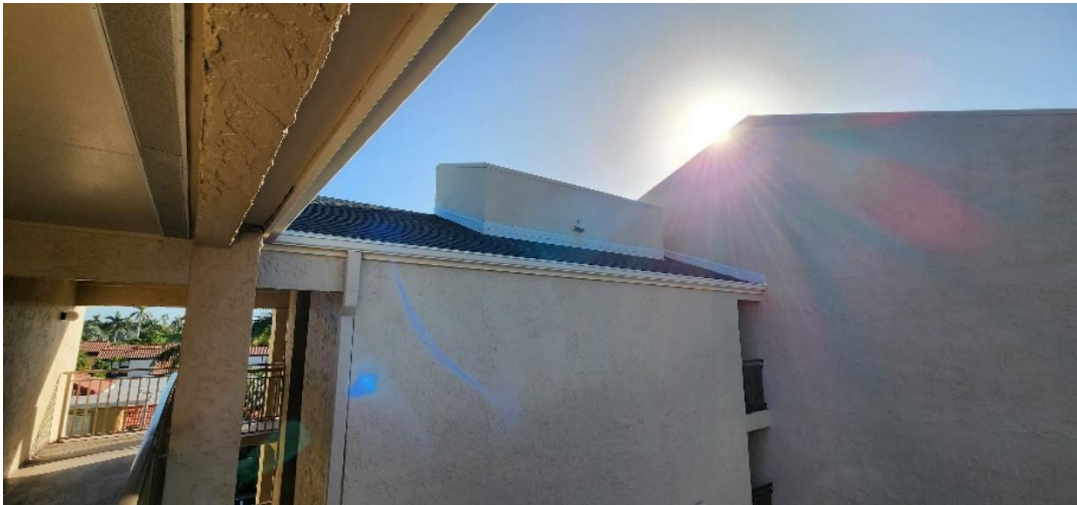
PHOTO 4

GENERAL VIEW OF STORM WATER INLET

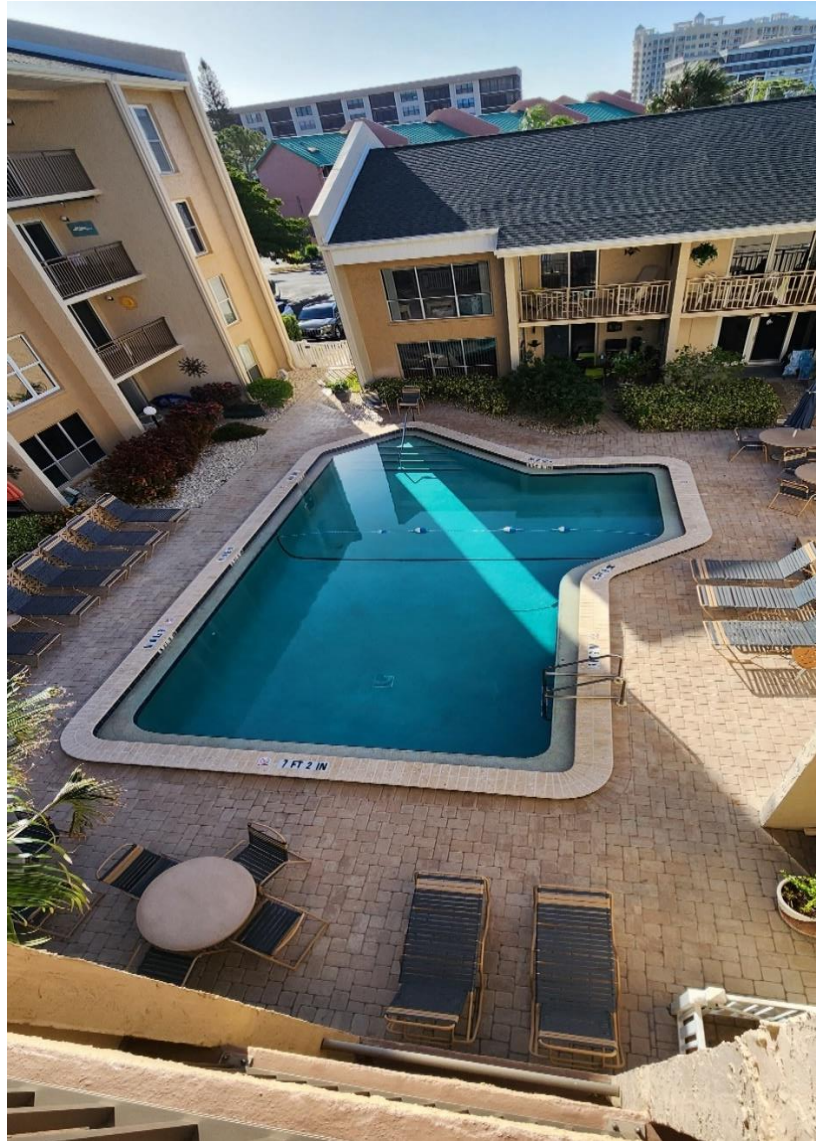
PHOTO 5

GENERAL VIEW OF SWIMMING POOL

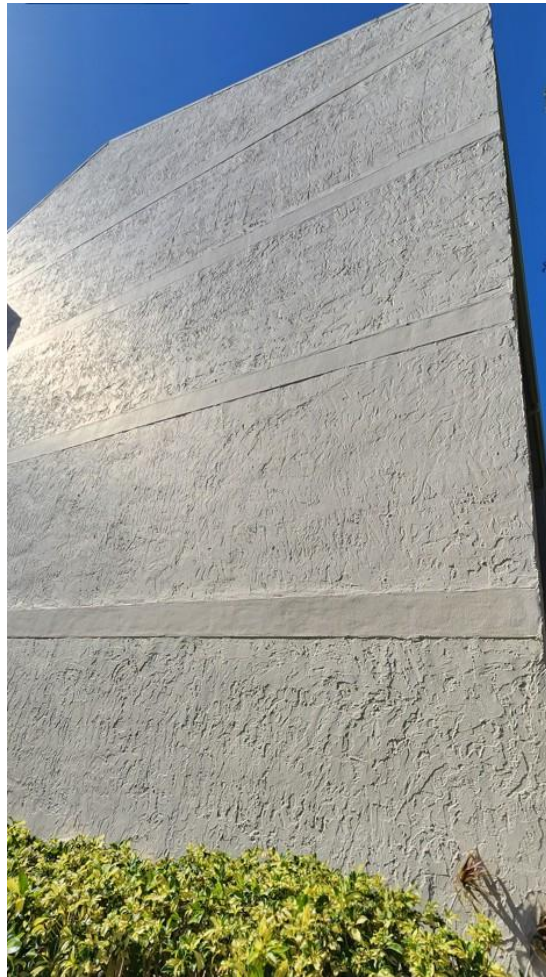
PHOTO 6

GENERAL VIEW OF BUILDING EXTERIOR FINISHES

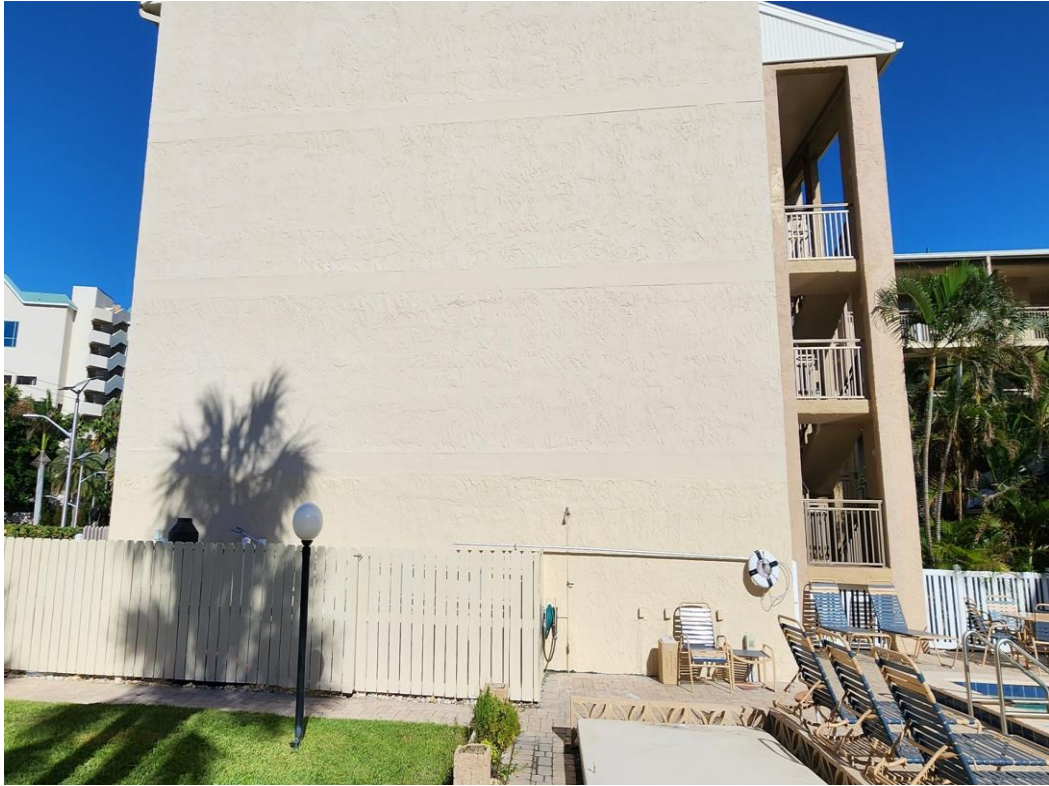
PHOTO 7

GENERAL VIEW OF BUILDING EXTERIOR FINISHES

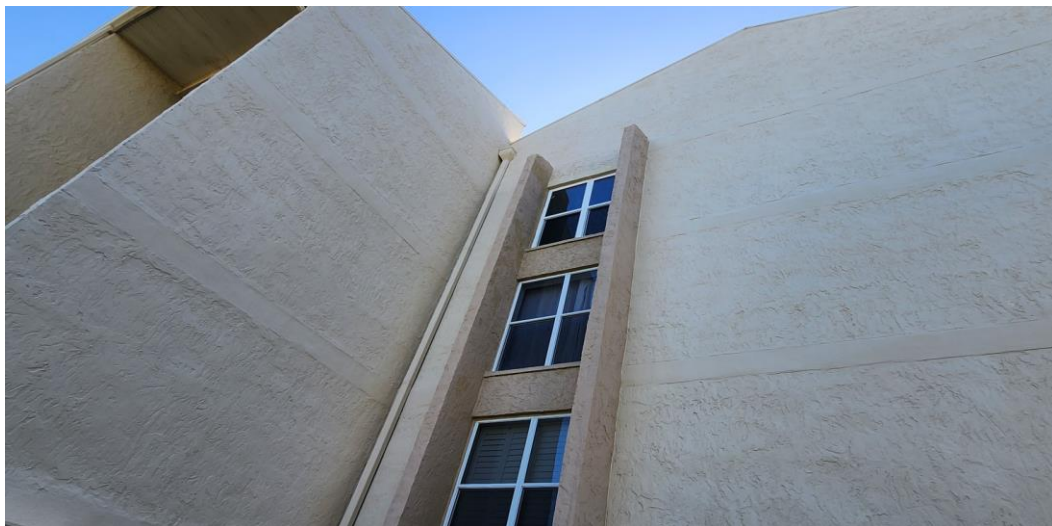
PHOTO 8

VIEW OF BUILDING EXTERIOR FINISHES

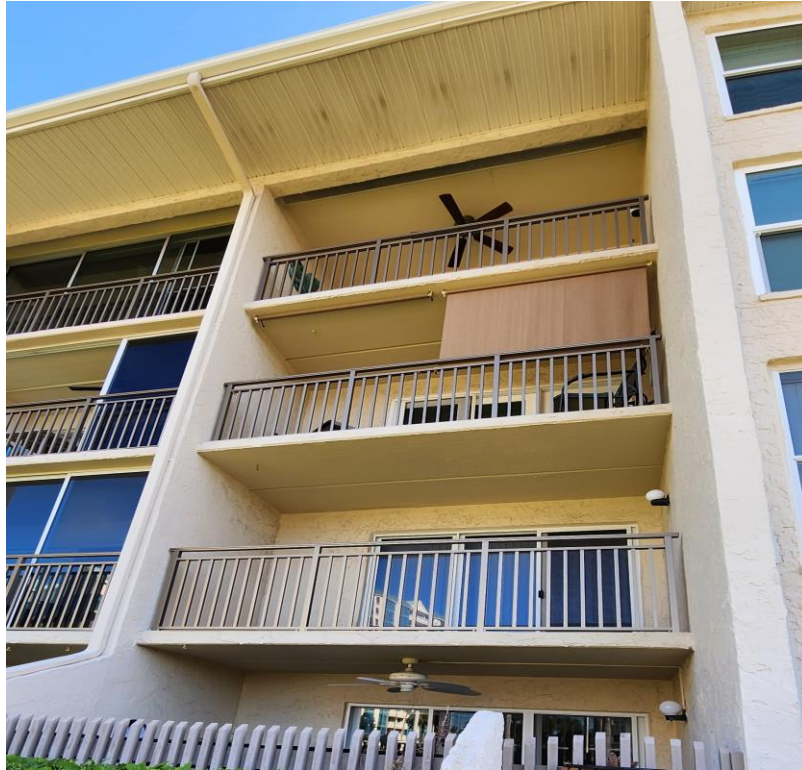
PHOTO 9

VIEW OF TYPICAL BALCONY

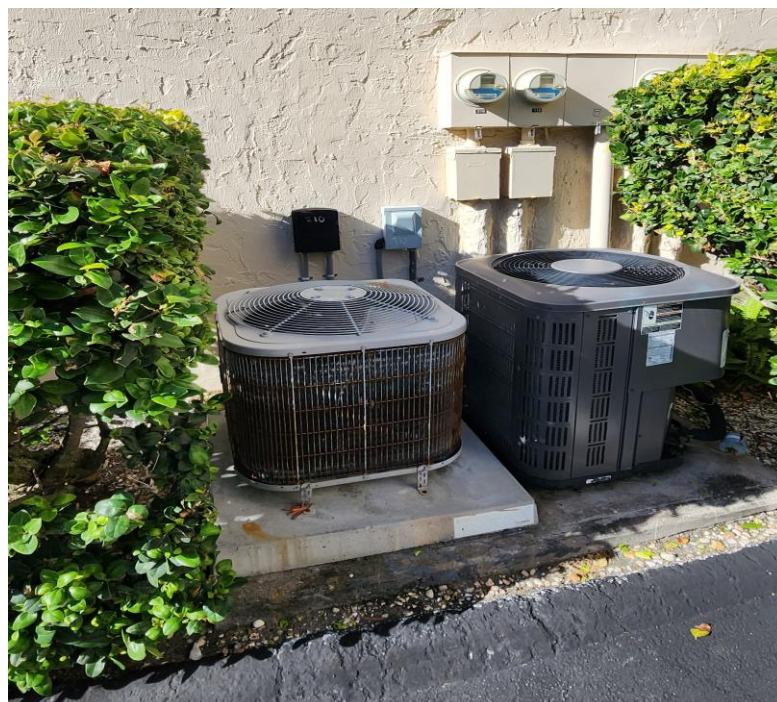
PHOTO 10

HVAC EQUIPMENT

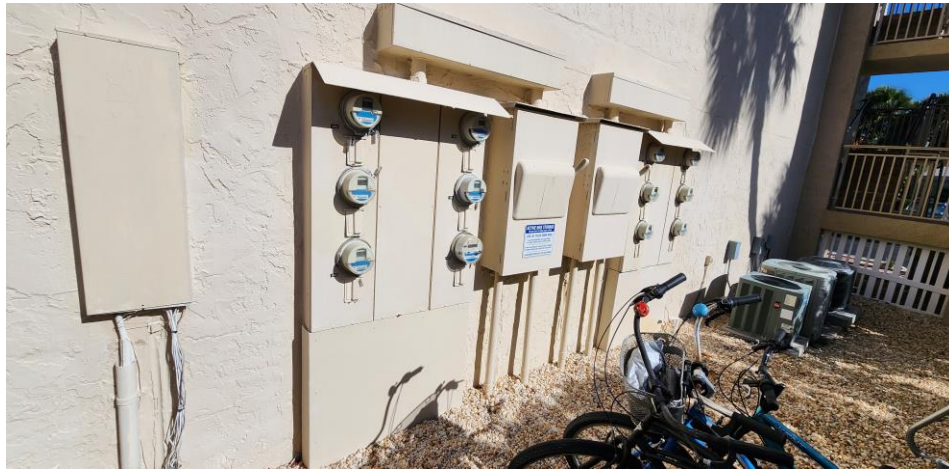
PHOTO 11

ELECTRICAL EQUIPMENT

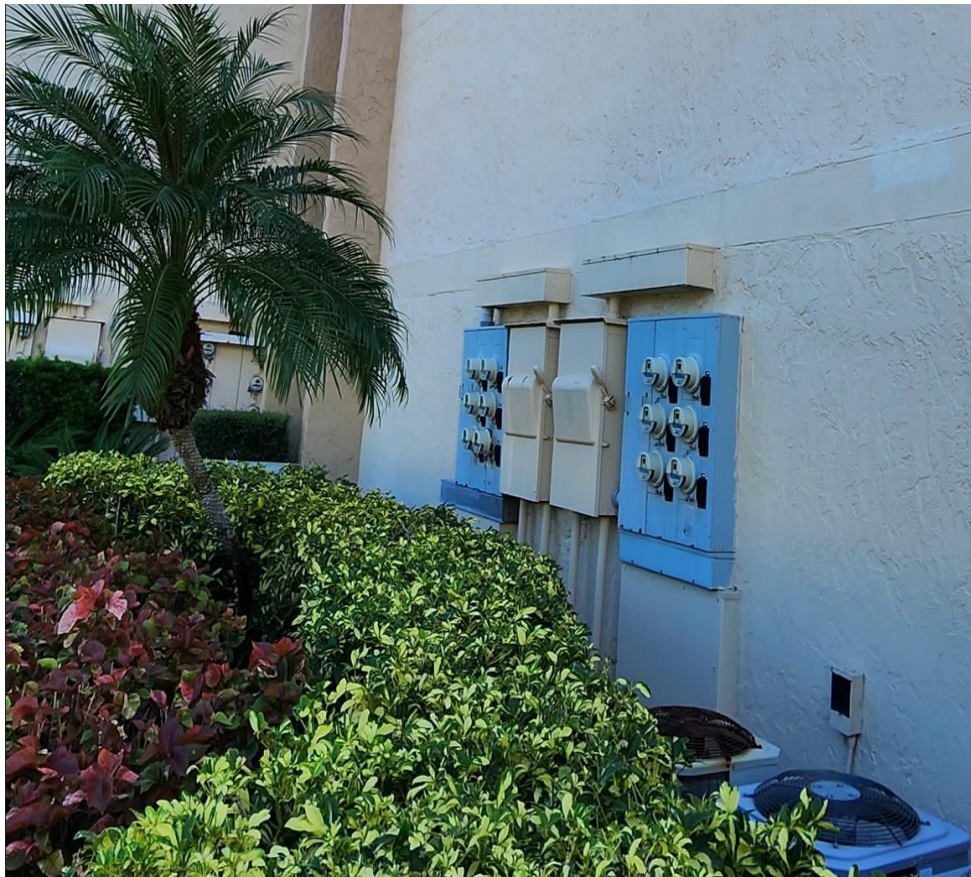
PHOTO 12

ELECTRICAL EQUIPMENT

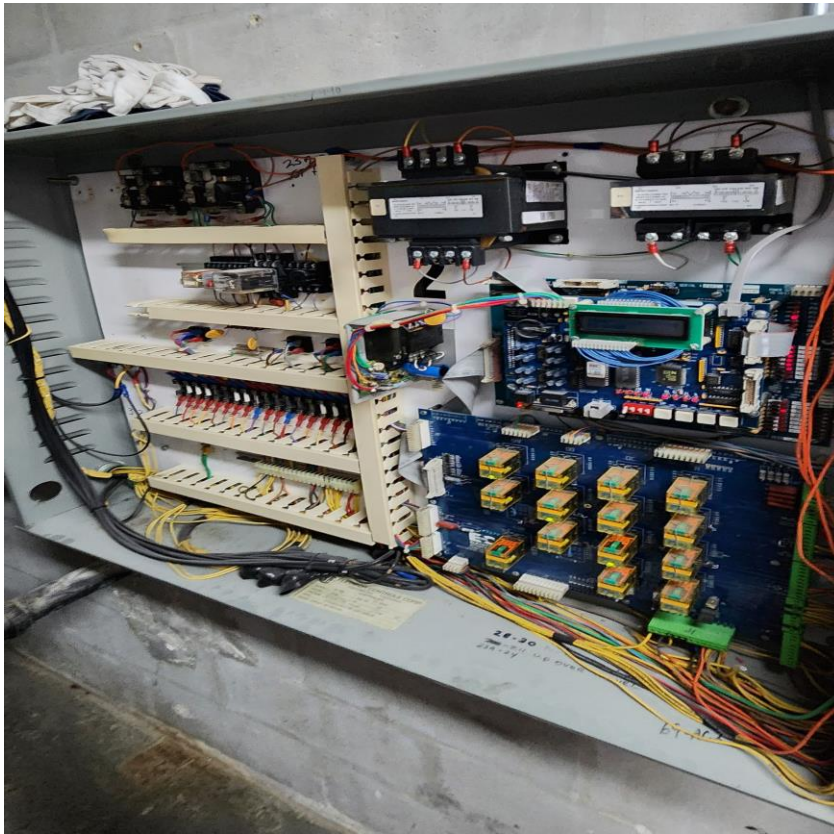
PHOTO 13

ELEVATOR ELECTRICAL SYSTEM

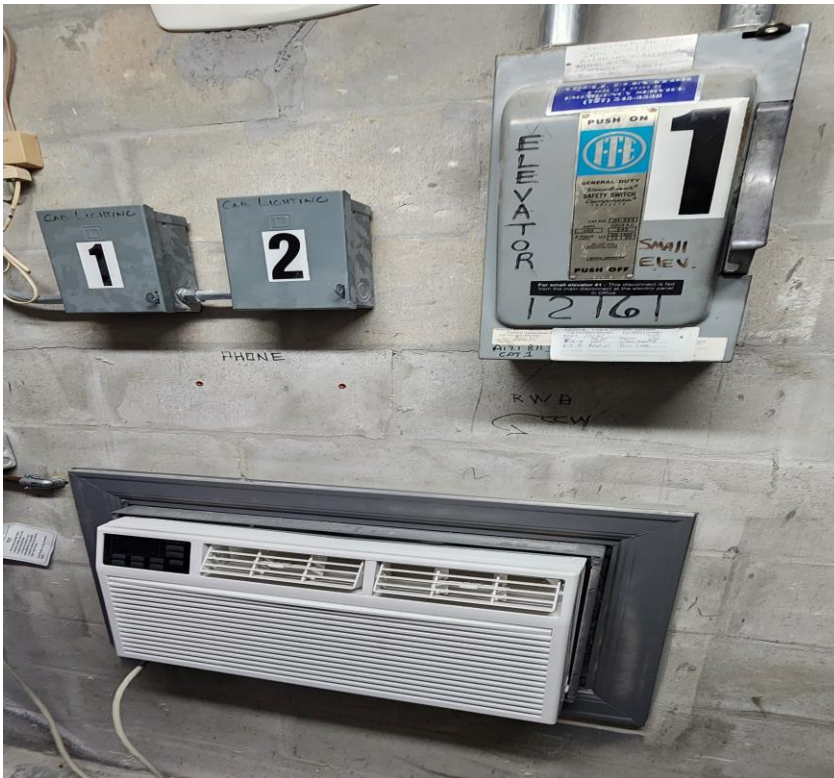
PHOTO 14

ELEVATOR DISCONNECT AND A/C

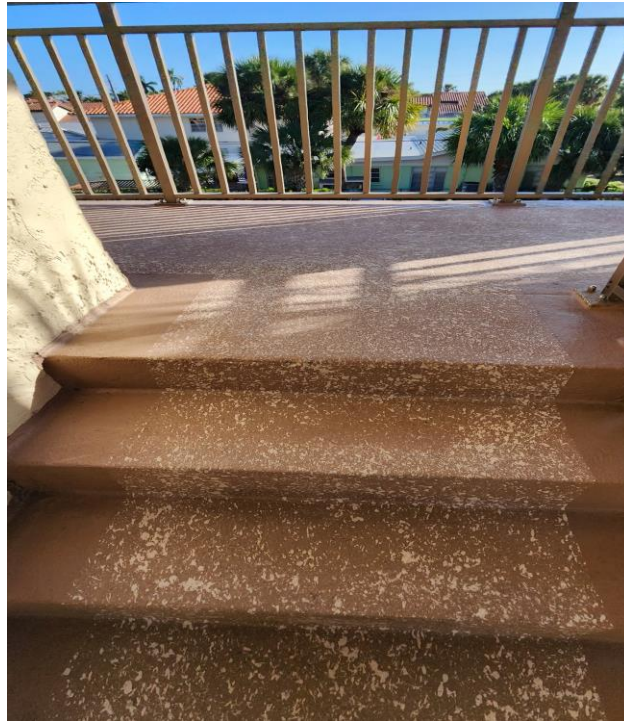
PHOTO 17

INTERIOR STAIRS

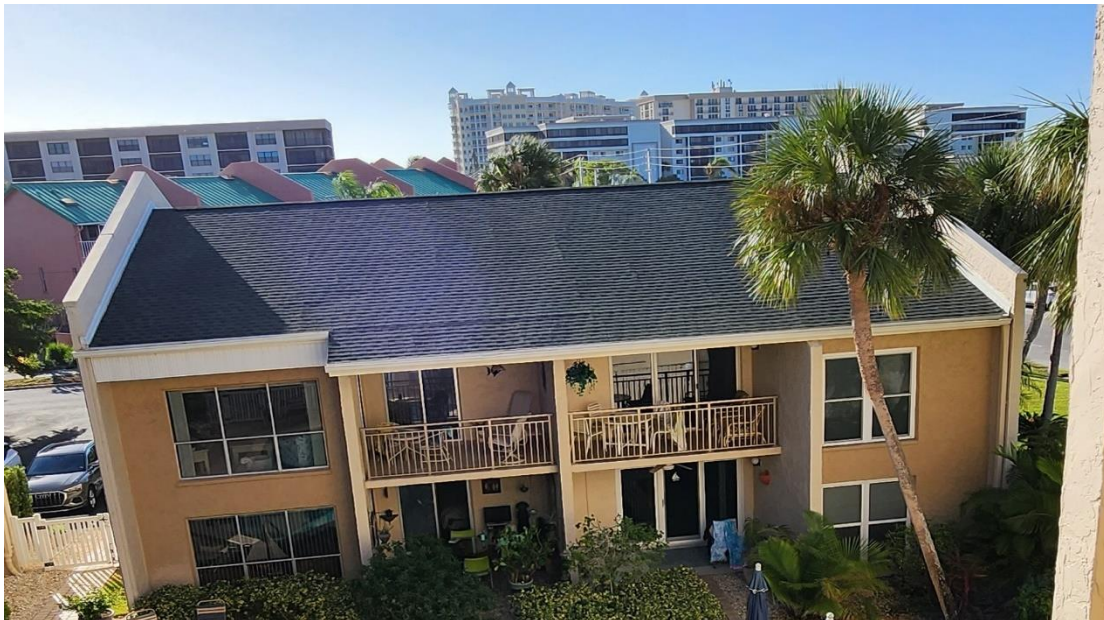
PHOTO 18

GENERAL VIEW OF ROOF

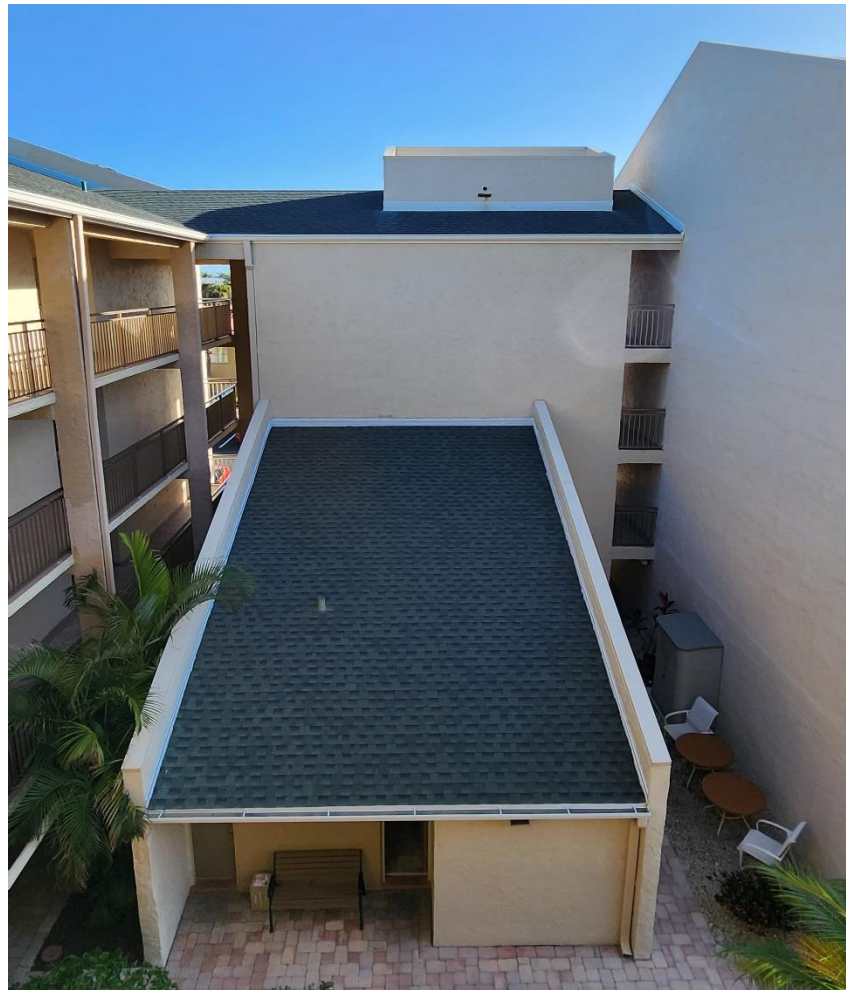
PHOTO 19

GENERAL VIEW OF ROOF

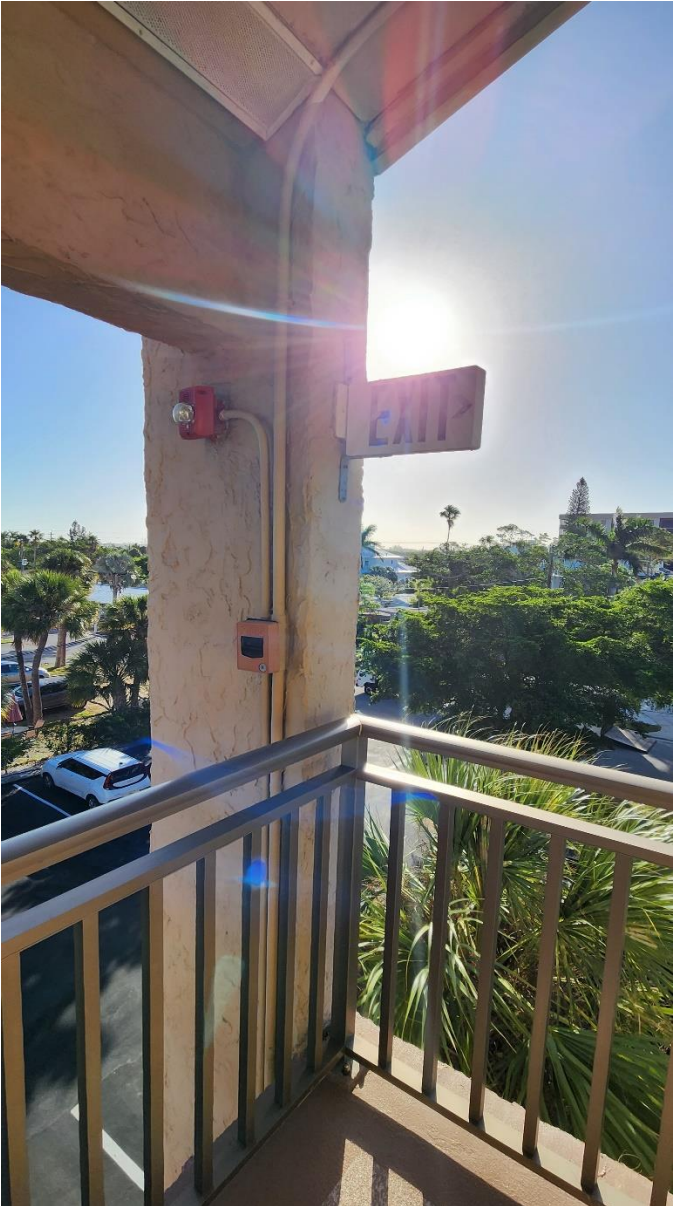
PHOTO 20

LIFE SAFETY DEVICES

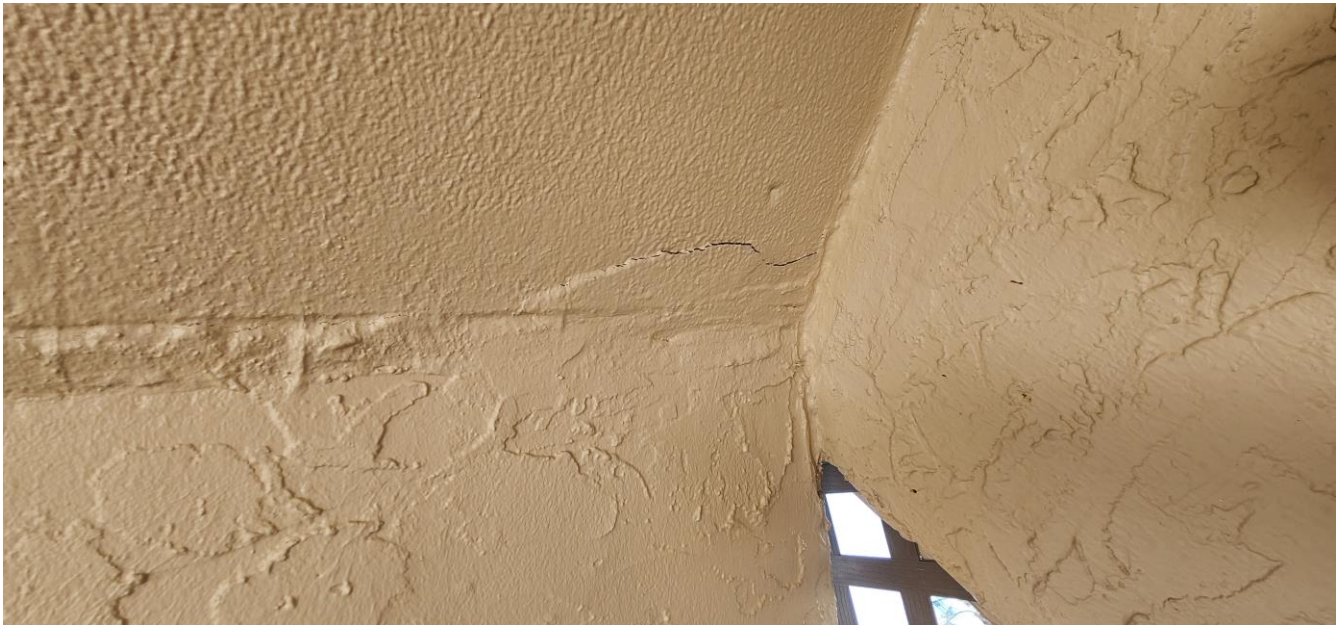
PHOTO 21

MINOR CRACKS BELOW THE STAIR

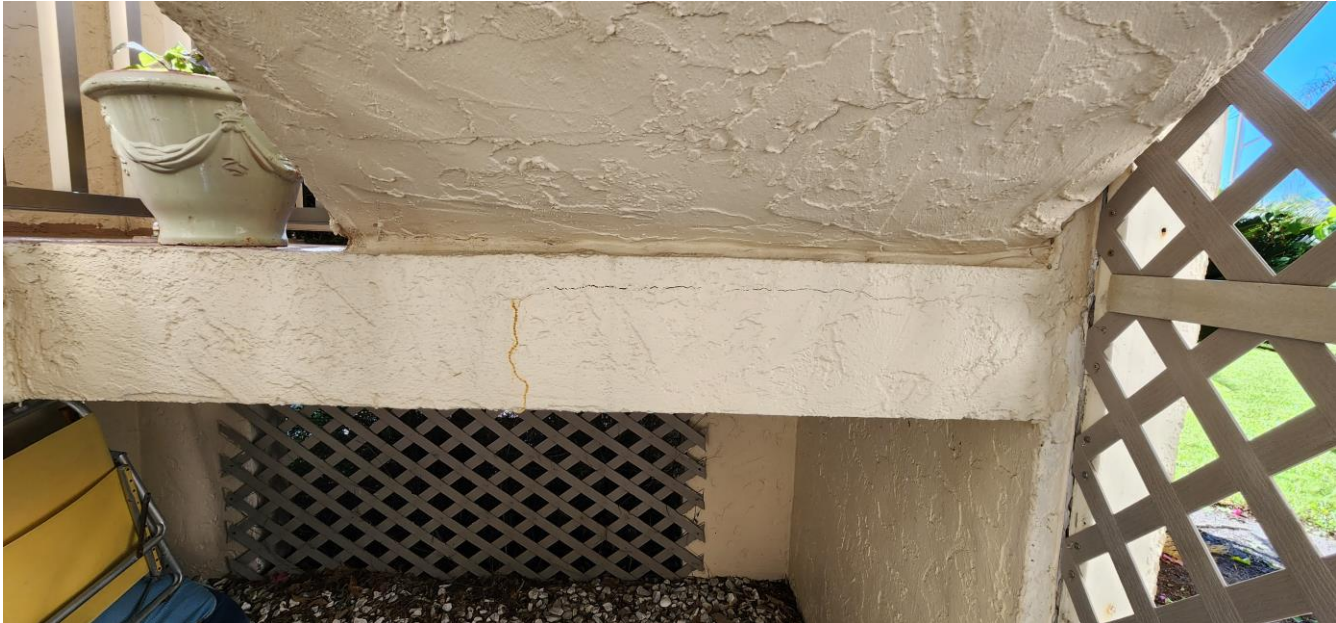
PHOTO 22

MINOR CRACKS BELOW THE STAIR

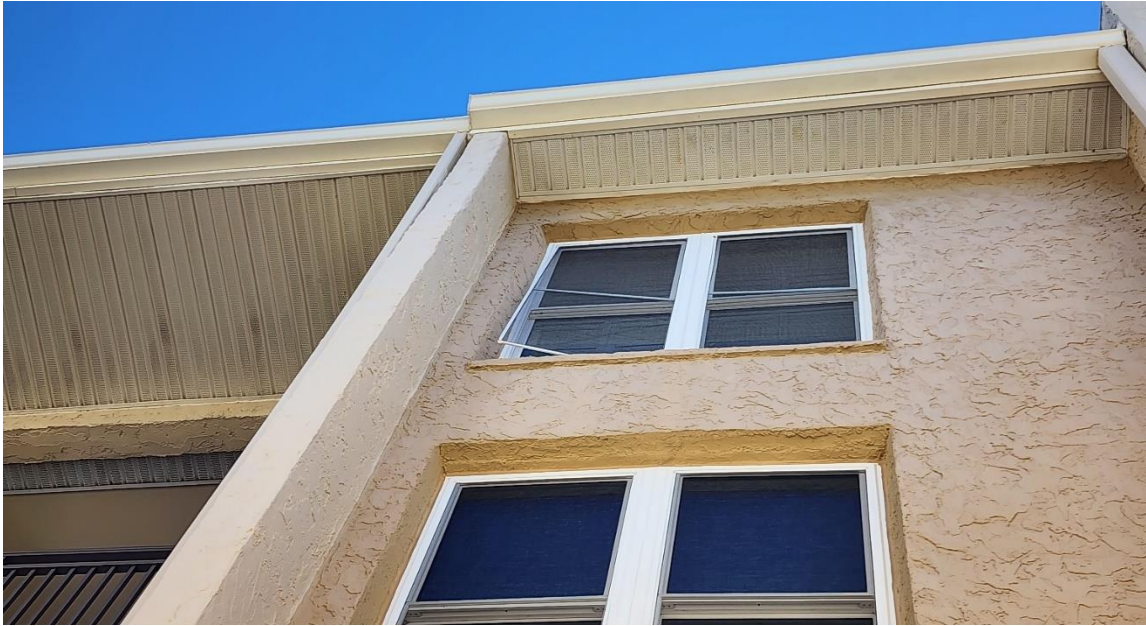
PHOTO 23

LOOSE WINDOW SCREEN

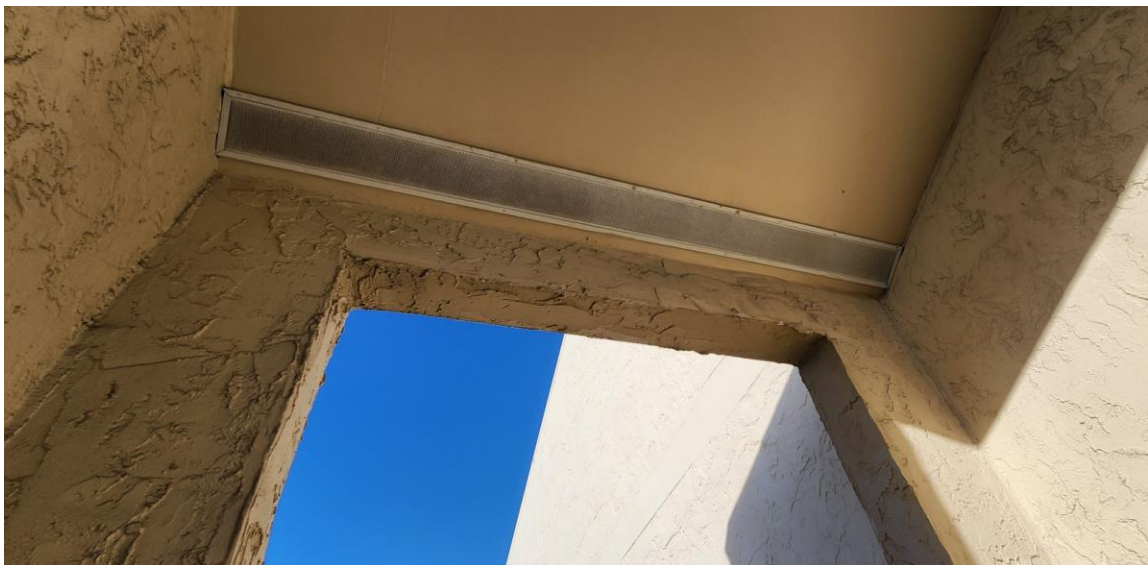
PHOTO 24

TYPICAL SUPPORT BEAM

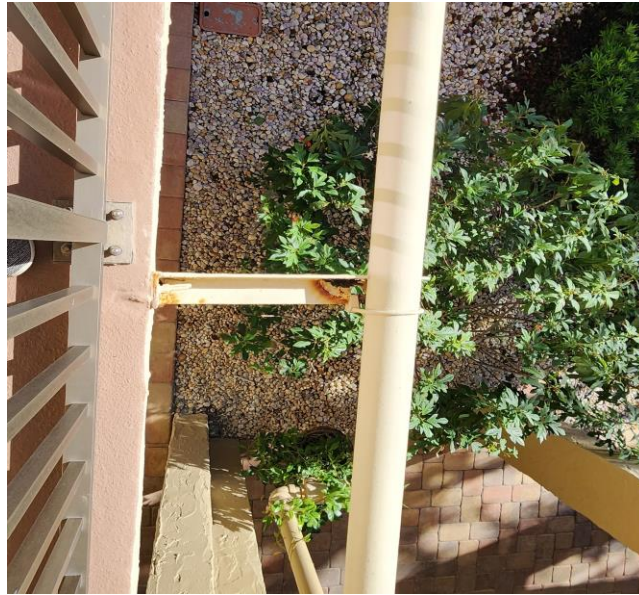
PHOTO 25

RUSTY FIRE RISER SUPPORT

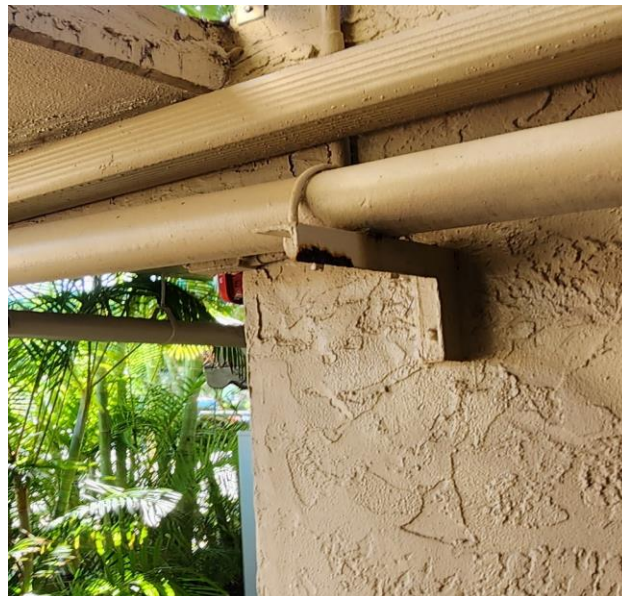
PHOTO 26

RUSTY FIRE RISER SUPPORT

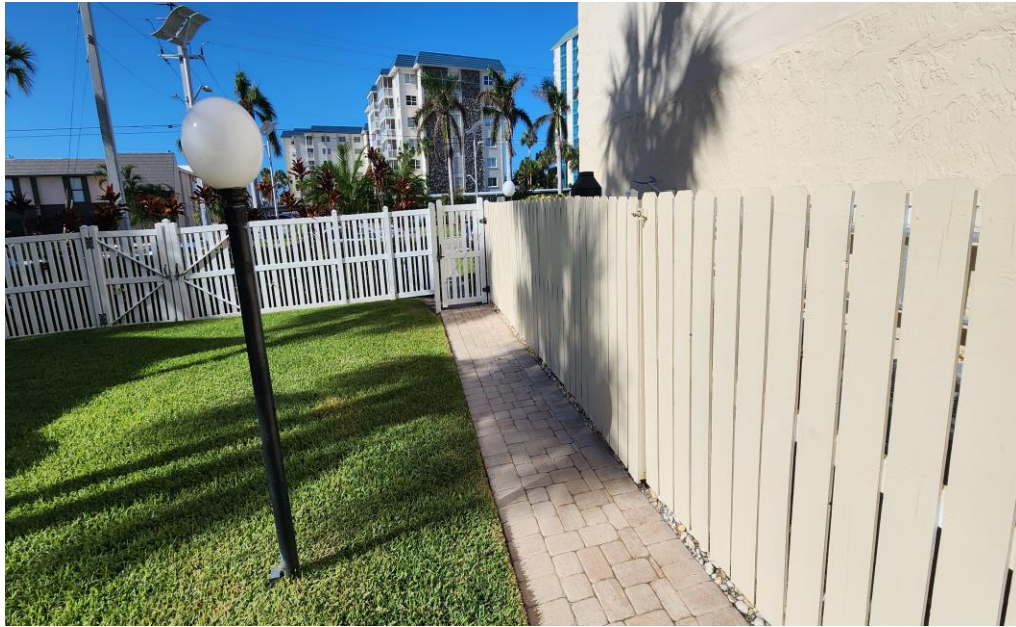
PHOTO 27

EXTERNAL LIGHTING

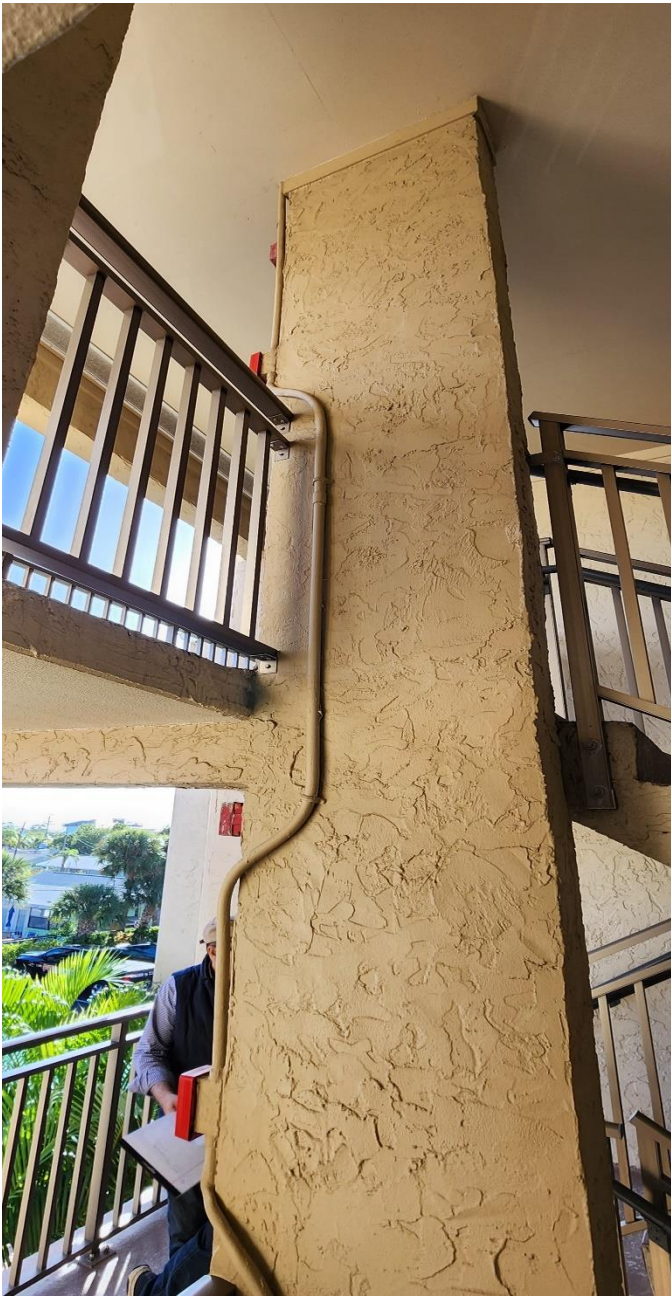
PHOTO 28

TYPICAL COLUMN
